## ■ CITY HALL, KINGSTON, ONTARIO

## ■ CHURCH OF THE HOLY TRINITY, TORONTO

# Heritage Buildings and Energy Conservation

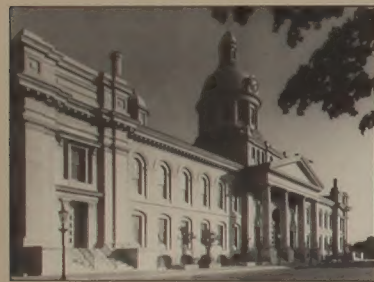
Low-cost measures led to big savings in historic Kingston City Hall.

Ed Preston and the 143-year old Kingston City Hall are proof that a little money, some common sense and a lot of dedication can create small energy-conservation miracles with municipal heritage buildings. Applying what he calls "the basics of energy conservation" to city hall, Preston, who is building maintenance foreman for the Kingston Parks and Recreation Department, saved the city approximately \$35,000 in energy bills between 1976 and

Together, these "low-cost and no-cost measures," says Preston, reduced kilowatt-hour consumption from 1,636,800 in 1976 to 1,039,800 in 1980.

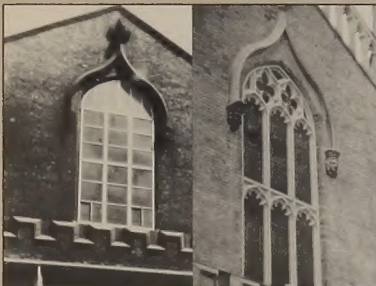
Left: Exterior storms hid the stained-glass windows and led to decay of the framing. Right: During restoration the storms were removed and the windows were caulked and re-leaded where necessary.

For his part, Higgins says his energy-conservation measures were necessarily modest, "since we wanted to preserve the original character of the church." First, Higgins removed the exterior storms, which had been mounted over the church's original stained-glass windows. "The storms were plain ugly, they leaked and were contributing to the decay of the wooden window framing and stained glass," he says. And he decided against new double glazing because he didn't feel he could justify "a \$50,000 expense for a saving of not much more than \$500 a year." Money was better spent, he says, "on basic air-infiltration control measures on the original windows."

Those measures included caulking, sealing and, where necessary, re-leading the stained-glass windows. They also included the addition of a new vestibule on the south side of the building to minimize drafts, and extensive weatherstripping to the doors of the existing vestibule. As well, at a cost of \$3,600 Higgins sealed all cracks and joints in the church ceiling to prevent hot air from leaking into the attic. He also restored the adjustable crawl-space vents located around the perimeter of the building. When open, the vents allow summer humidity to escape; closed, they keep winter's chill outside.

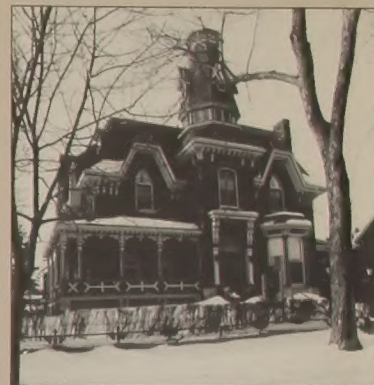
The Hochelaga Inn in Kingston is being restored to maintain the look and function of a heritage building, while providing the comfort of a modern inn.

To capture the sense of the original interior spaces, Downey went so far as to obtain original architectural drawings along with basic sketches of the building from the National Archives in Ottawa. His energy-conservation measures, on the other hand, were less dramatic, one such measure was the addition of an interior pane of glass to each window sash.

"Others," says Downey, "might have sealed the windows and air-conditioned the building. We just didn't think it was warranted here. Part of the character of a heritage building is not only its look but its function. By adding interior panes, we were able to maintain the windows as operating windows." (see chart on page 4)

4. The method the architect finally chose was more modest than the alternatives. It consisted of weatherstripping the existing windows and installing a pane of glass on the inside of each sash against the frame. Not only was this method much less expensive than the other options, but it preserves the original windows, allows them to be opened in the normal way, and scarcely changes their appearance.

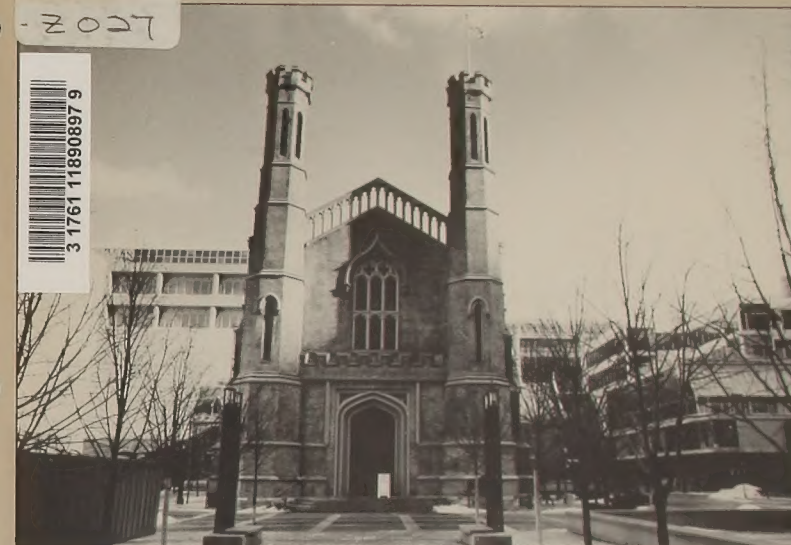
The restored 140-year-old Church of the Holy Trinity sits in the shadow of the Eaton Centre in downtown Toronto. Renovations, including conservation measures, have resulted in increased use of the building seven days a week.
